**PRELIMINARY  
GEOTECHNICAL REPORT**

**MATHER SOUTH PROPERTY  
SACRAMENTO COUNTY, CALIFORNIA**

**Prepared by:**  
ENGEEO Incorporated

**August 29, 2012**

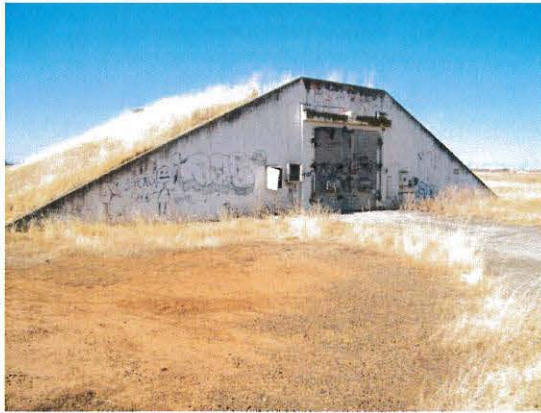
- The central portion of the property includes fencing, asphalt concrete pavements, and multiple abandoned CMU buildings, concrete bunkers and shop areas associated with the former Mather Air Force Base.

Typical Concrete Storage Bunker

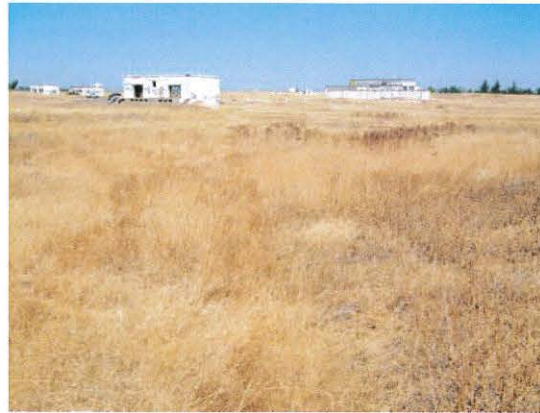
Overview of Structures

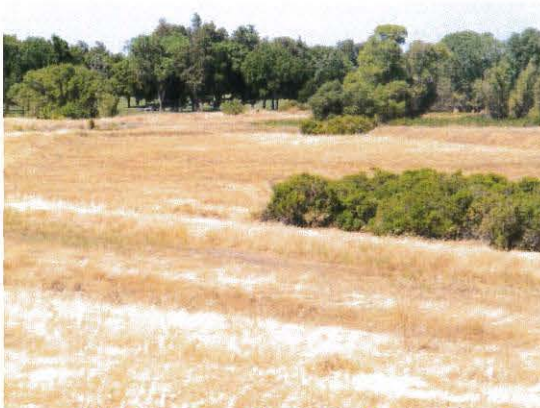
- Various soil fill and debris piles are located across the site. The most notable are near Mather Lake to the north and another near the intersection of Kiefer Road and Eagles Nest Road at the southwest corner of the site. Additionally, large volumes of fill were placed onsite during construction of the Folsom South Canal.

Fill berms south of Mather Lake

We recommend that existing fill be removed to competent native soil, as determined by ENGEO. As described in Section 2.1, Site Background, fill was spread across a large portion of the site during construction of the Folsom South Canal in the late 1960s and early 1970s. According to Sacramento County representatives, much of the fill may have been placed in a layer less than 1 foot thick. Estimated fill extents, based on a 1971 aerial photograph, are shown on Figure 2. The lateral extent and depth of fill will vary. Future design-level geotechnical work, including subsurface explorations, will help to further identify fill areas and depths and provide specific details for remedial earthwork.

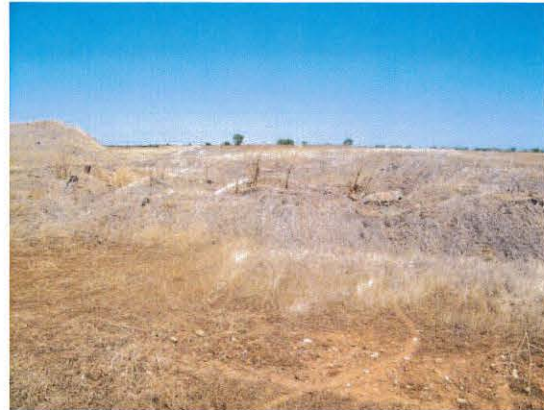
Soil piles at southwest corner of site

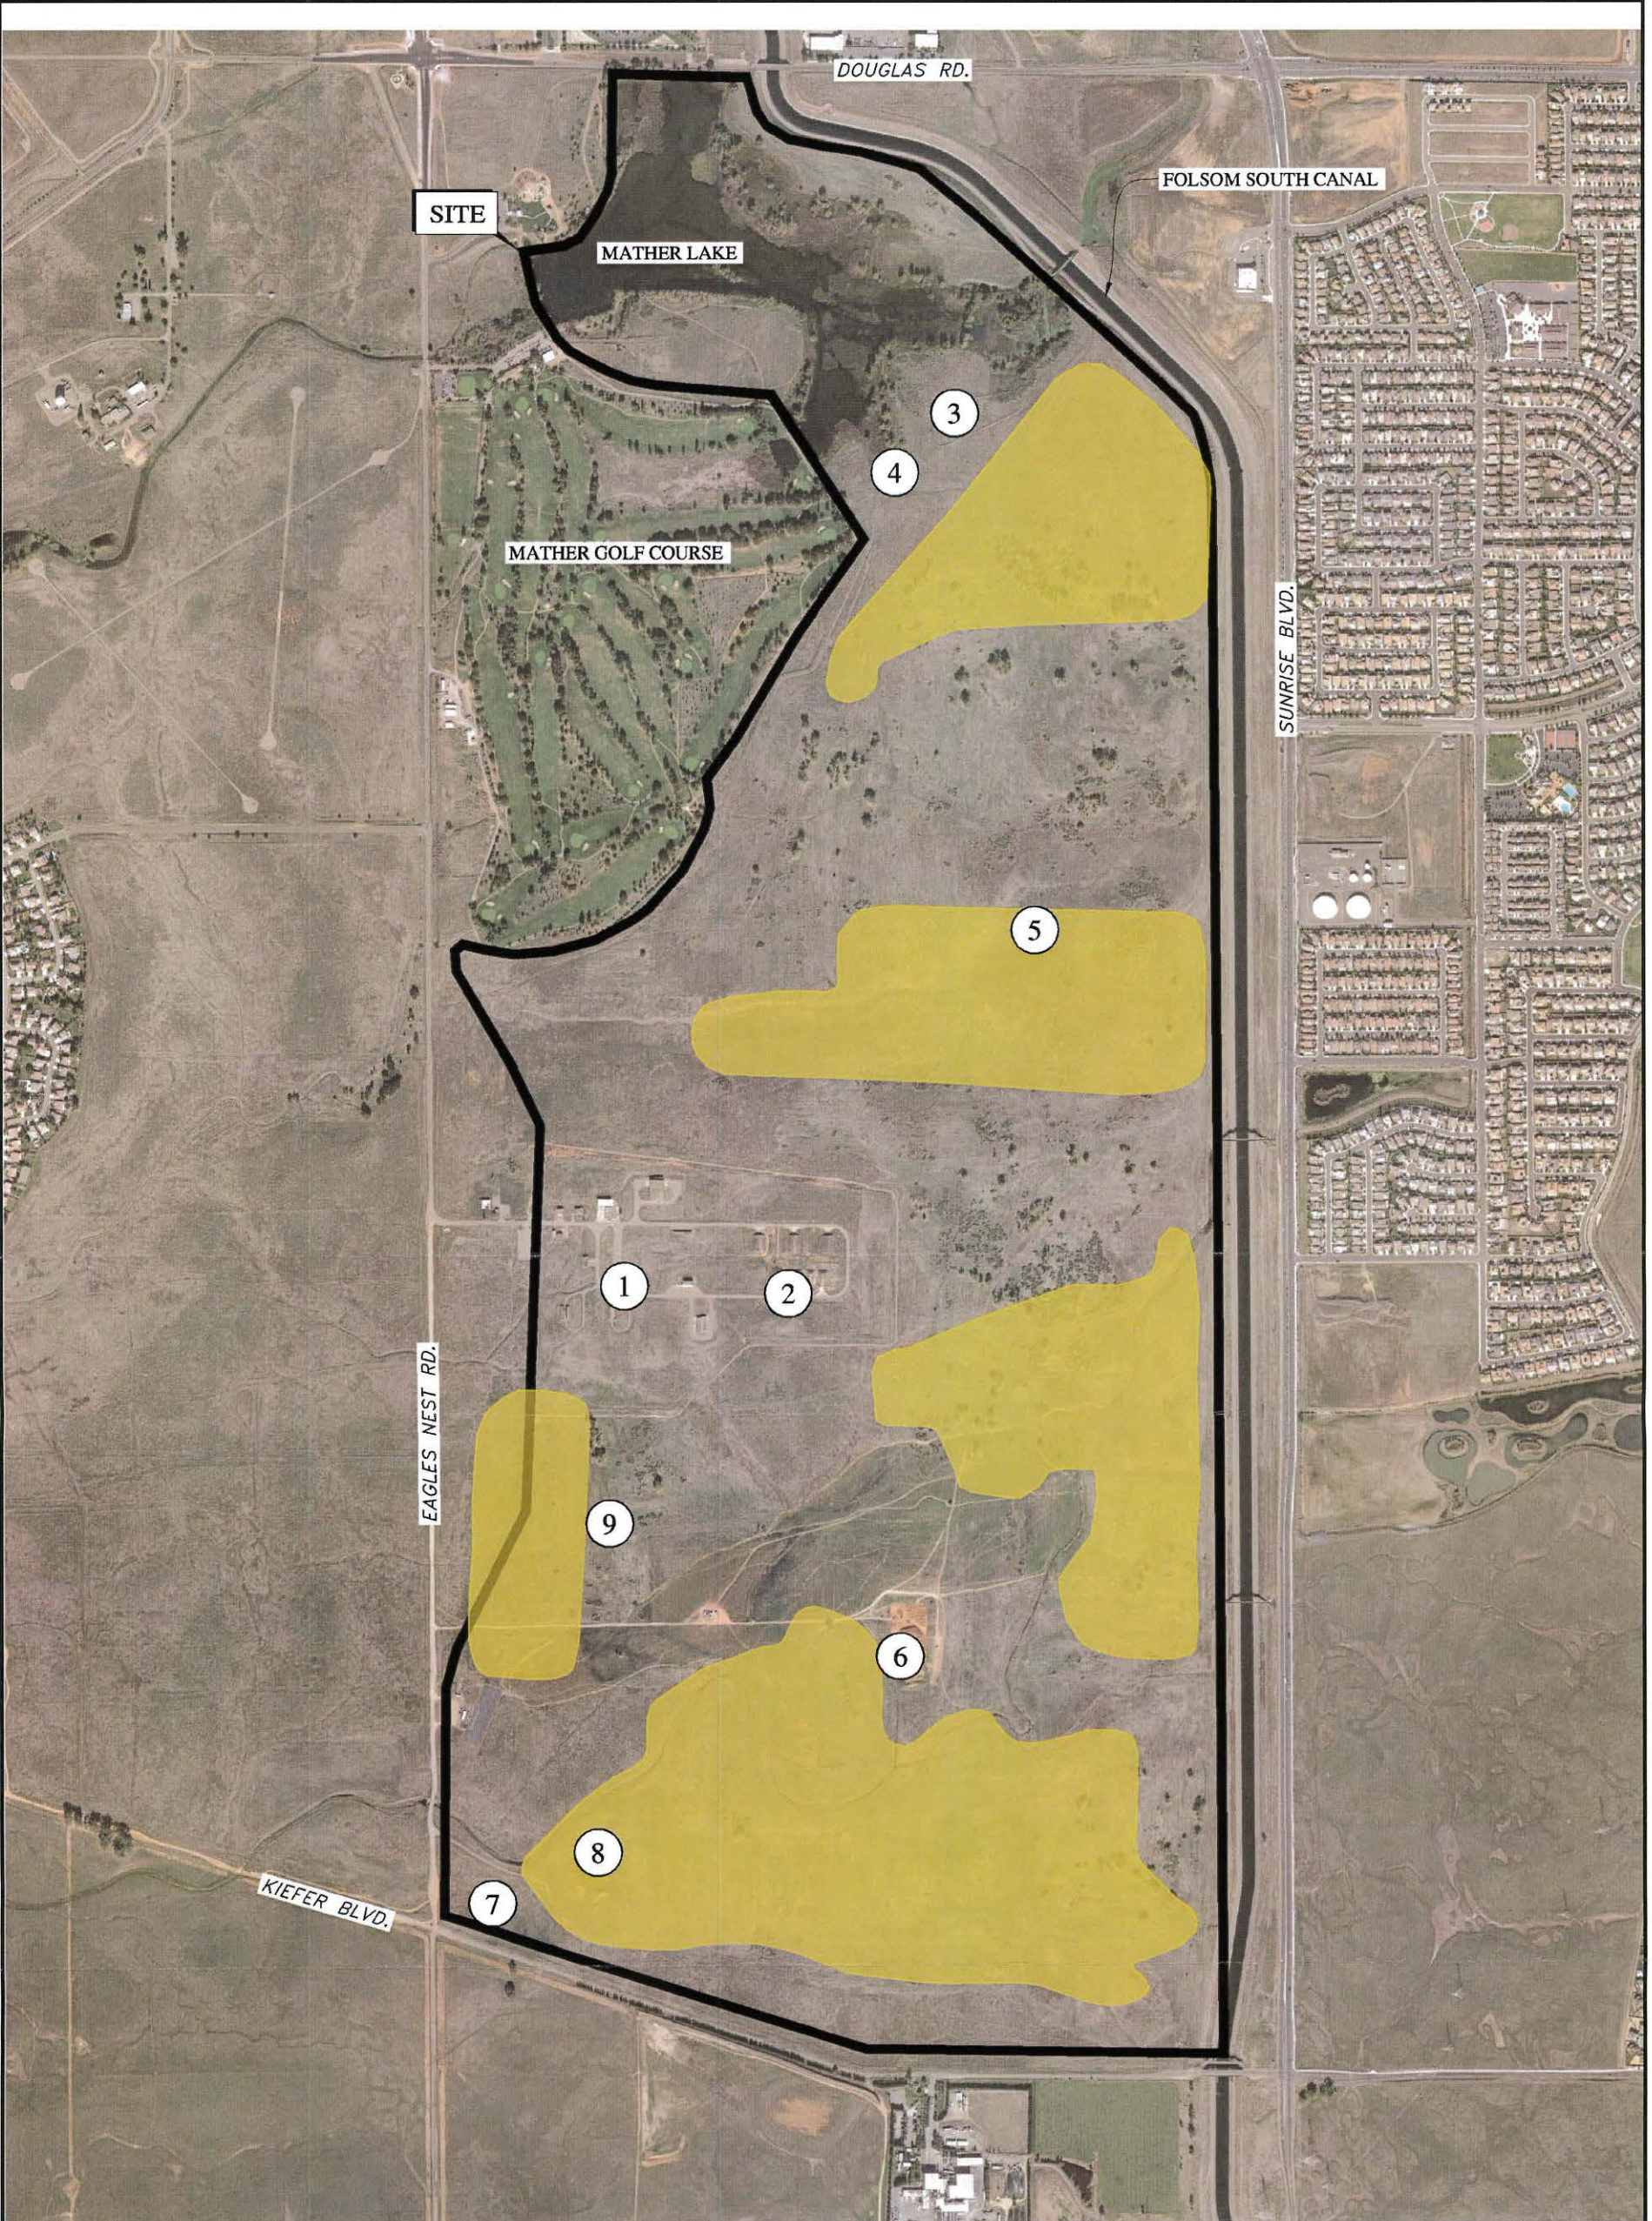
Based on aerial photographs (see below), in the late 1960s and early 1970s the Folsom South Canal was constructed parallel to the eastern border of the site. Excavation spoils from the canal appeared to have been spread on the Mather South property. The approximate lateral extents of that fill is shown on the Site Plan, Figure 2.

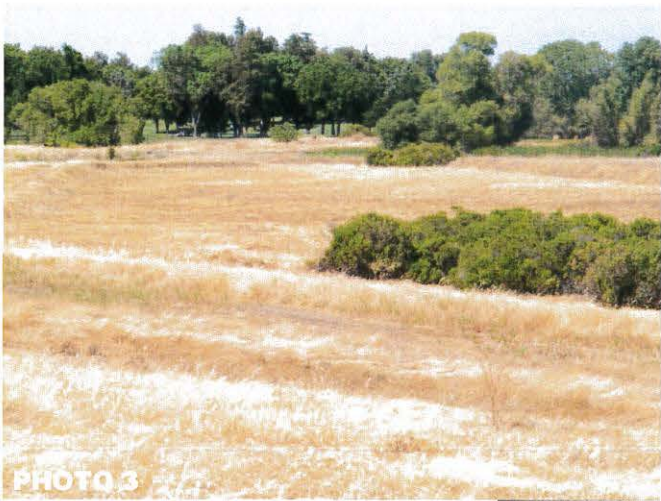
**PHOTO 3**  
CIRCULAR BERM FEATURE ADJACENT TO MATHER LAKE

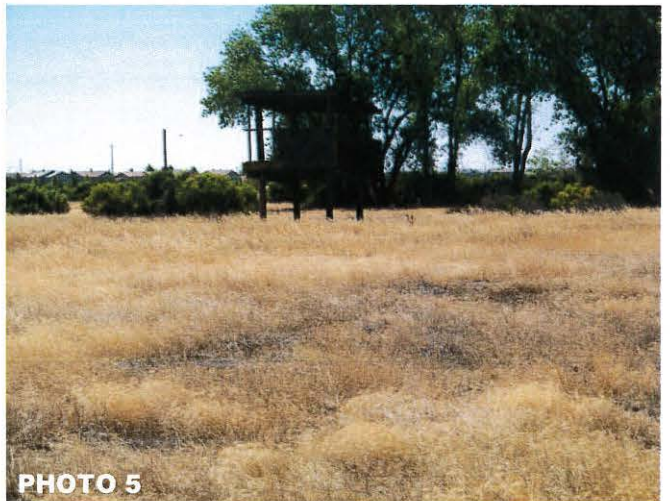
**PHOTO 5**  
OBSERVATION PLATFORM

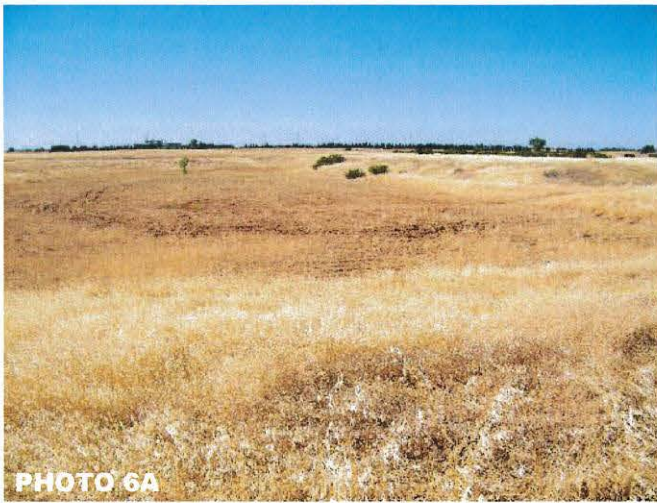
**PHOTO 6A**

FORMER ORDNANCE BURNING AND  
DETONATION AREA XE404 - OT-69

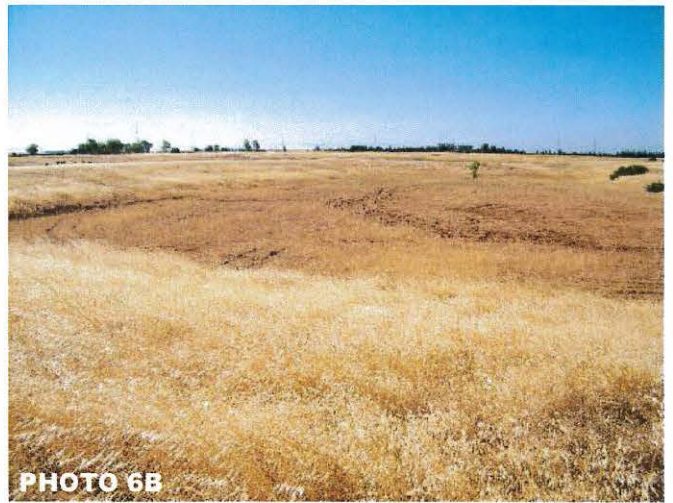
**PHOTO 6B**

FORMER ORDNANCE BURNING AND  
DETONATION AREA XE404 - OT-69

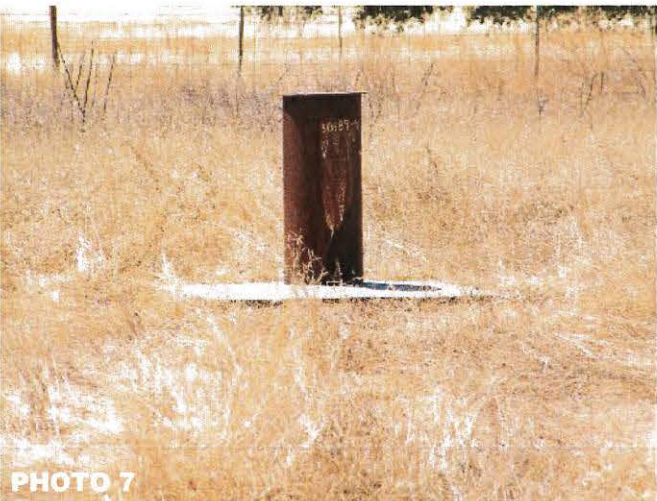
**PHOTO 7**

- What appeared to be a well standpipe was observed near the southwest corner of the property.

WELL STANDPIPE AT SOUTHWEST CORNER

We observed at least one existing well standpipe during our site reconnaissance. Unless the well will become a part of the future development, it should be abandoned by a licensed well drilling contractor in accordance with Sacramento County Environmental Health Department regulations. Removal of wells will likely require permitting through Sacramento County.

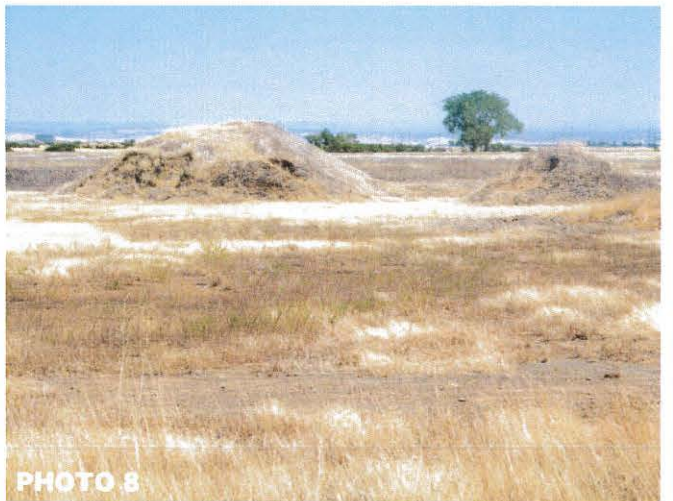
**PHOTO 8**

FORMER SMALL ARMS FIRING RANGE AREA OT-86
